**WESTPOWER EXECUTES THE  
HYDRAULIC RE-RATE OF A  
MAJOR US REFINERY'S CRUDE  
CHARGE PUMP, ALLOWING  
THEM TO REALIZE THEIR  
RELIABILITY  
POTENTIAL.**

**PROJECT OBJECTIVE** | Minimize  
costs to upgrade a historically  
inefficient crude charge pump

**SERVICE TYPE** | Engineering, Pump  
Re-Rate, Repair, Reliability, Performance &  
Efficiency Enhancements

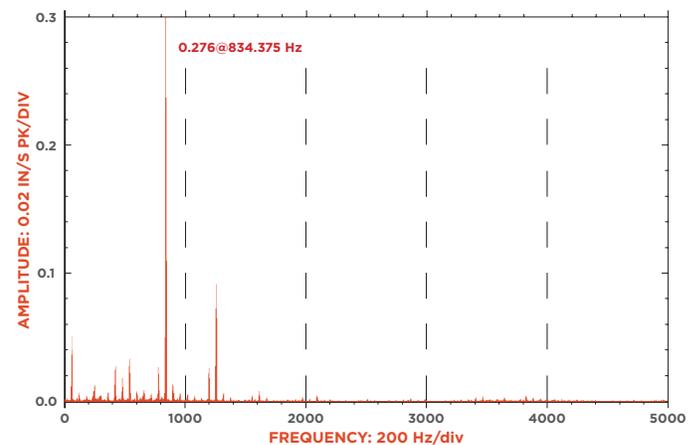
**FIGURE 1 |** Vibration spectrum of P21020 inboard bearing with very high vibration before the re-rate.

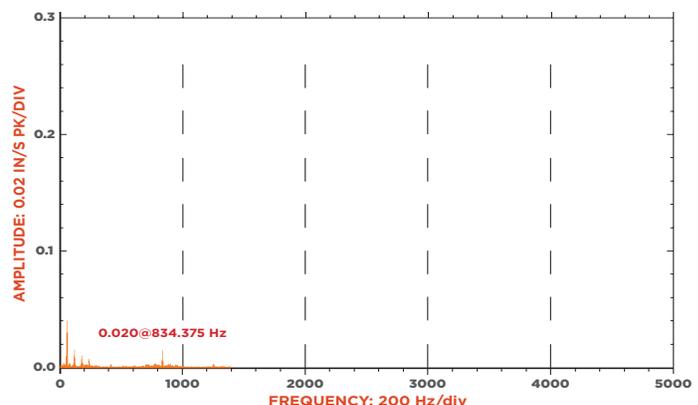
**FIGURE 2 |** Vibration spectrum of the inboard bearing after the re-rate. Direct vibration amplitude decreased significantly from 0.420 in/s pk to 0.060 in/s pk while the vibration amplitude at vane pass frequency (834 hz) decreased from 0.276 in/s pk to 0.020 in/s pk.

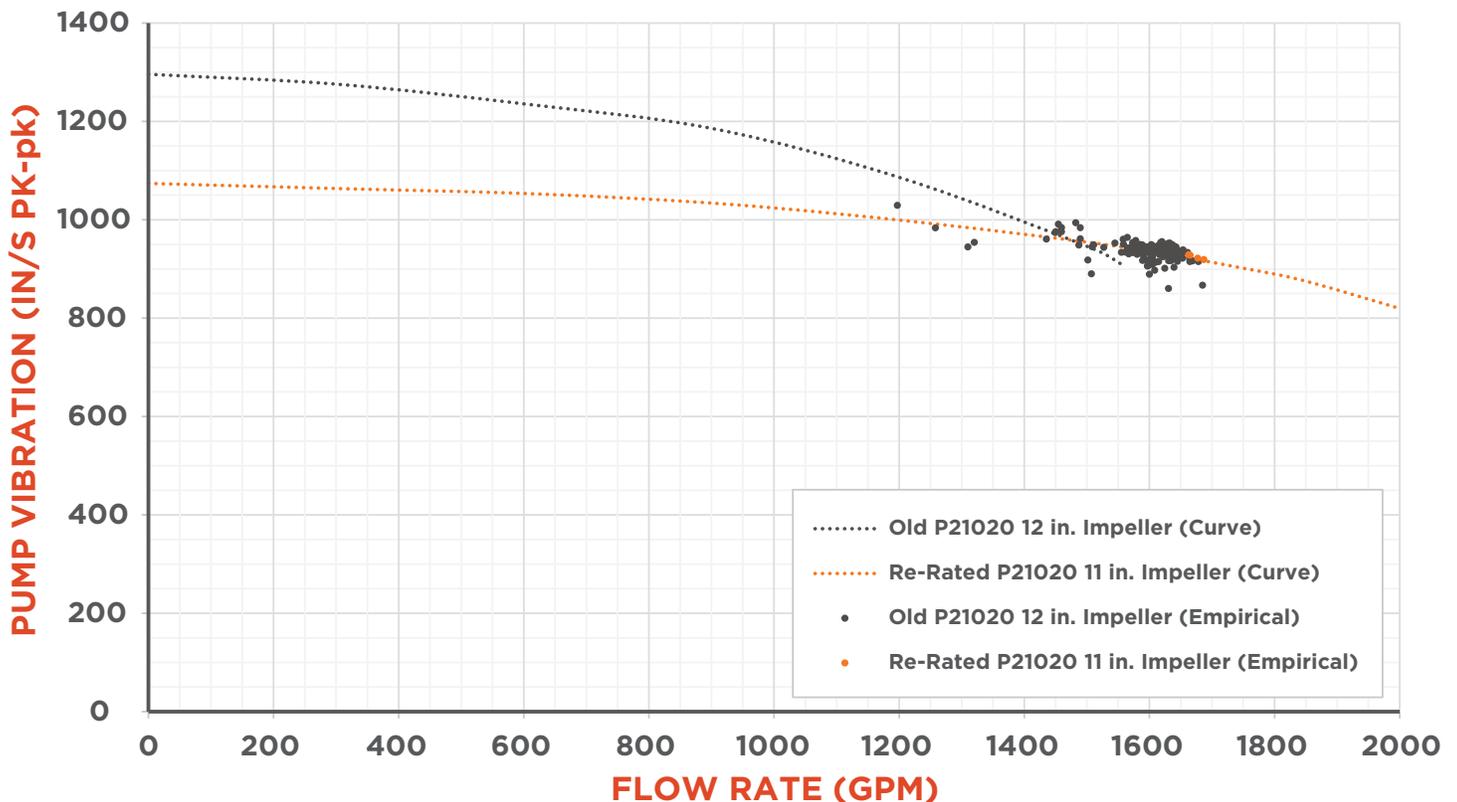
**FIGURE 4 | Pump Performance Before and After Re-Rate.** Compares the performance of the crude charge pump before and after the re-rate relative to the published pump curves. The actual performance of the re-rated pump is within 1% the published curve.

The successful outcome of this initiative was the result of Westpower’s engineering and technical expertise, that delivered a cost effective and reliable solution within the bounds of the project’s scope. By optimizing the pump curve, Westpower produced a pump solution that worked for the Client’s operating conditions and requirements rather than the Client having to adapt to a rigid pump specification and accept inefficient operations. The Client now achieves the required flow by running one pump instead of the two pumps that were previously required.

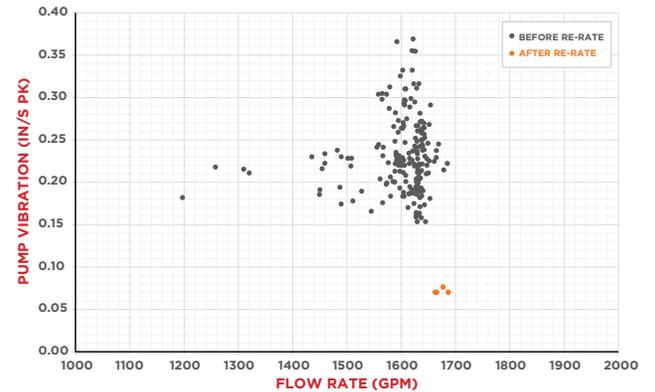
**FIGURE 3 | Before and After Vibration at Various Pump Flow Rates.** Vibration level of the crude charge pump as a function of flow rate. After the re-rate, the pump has been operating at historically low vibration levels, around 1675 gpm.
